## Case Studies: Discovering Mercury During Renovations

or  
How a Simple Project gets Complicated

## Duke South

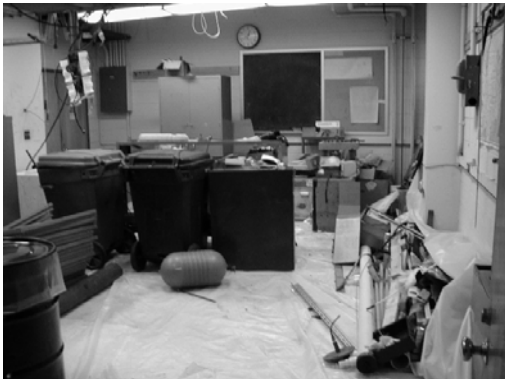
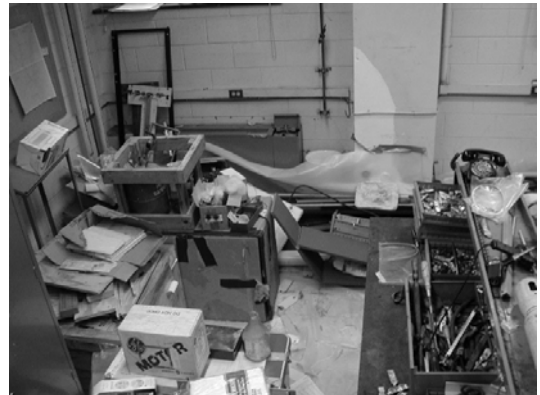
- In August 2002, EP contracted Clym Environmental Services (Clym) to remediate the room.
- In order to remediate 0042, the excess equipment stored in the room had to be removed.
- Room 0036 was lined with plastic and the equipment was moved.....

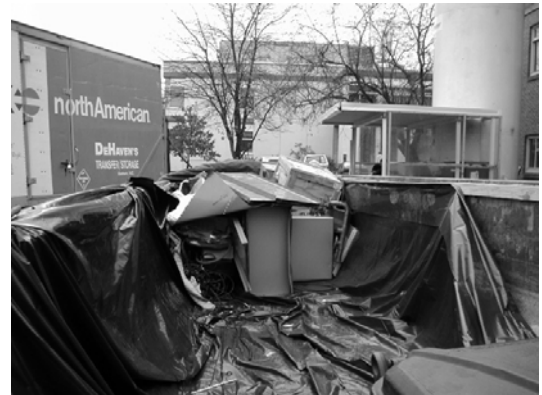
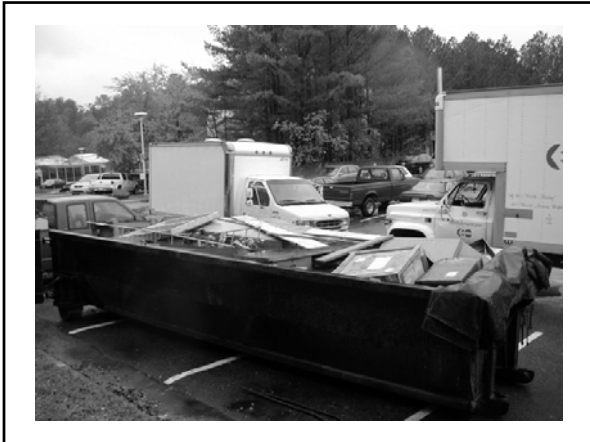
- Clym and EP determined that the equipment in 0036 and 0040 was contaminated with mercury dust. Highest reading 1000 ug/swipe.
- So now what?????
- After talks with the Physics Department, plan is to decontaminate the equipment in room 0040 and dispose of the equipment in room 0036.

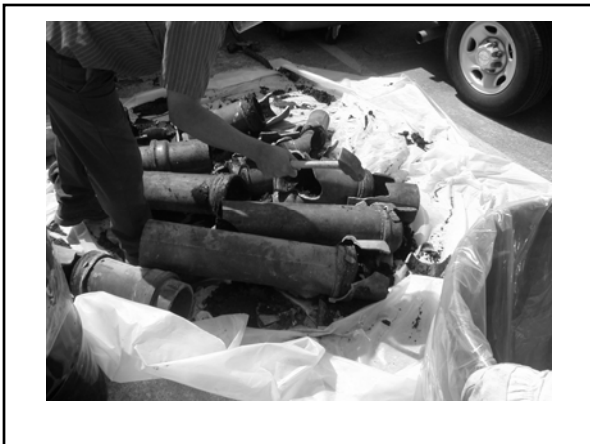
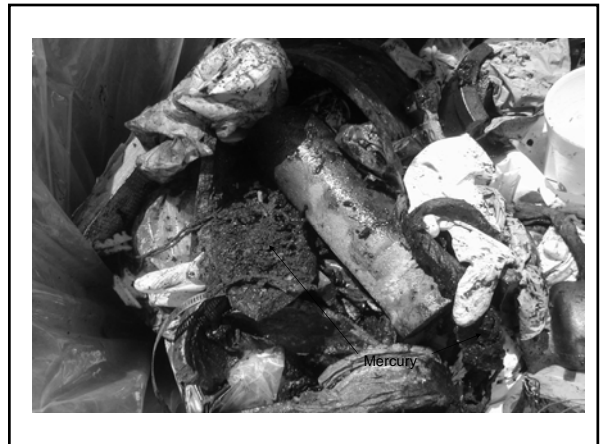
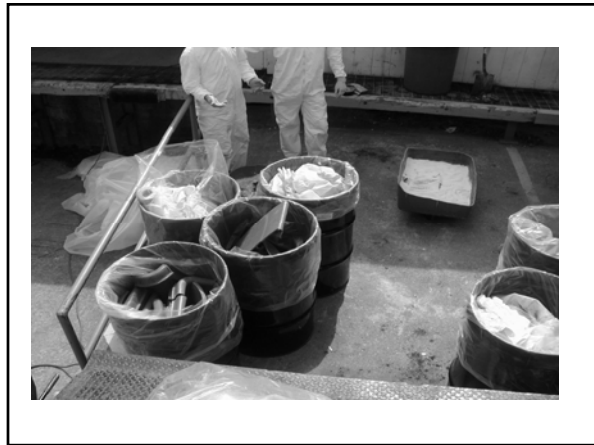
- E&O personnel noticed "silver stuff" on the plastic lining after removing a section of pipe.
- E&O Plumbing Shop Supervisor called Afterhours Spill Responder for help.
- While waiting for the Afterhours Responder, E&O personnel checked the piping and discovered the extent of the problem.
- Afterhours Responder, and other OESO personnel (Karen picked a good weekend to go to DC) evaluated the site.
- They:
  - decided to encase all piping in plastic for future (Monday) packing for disposal
  - decided to provide drums to E&O prior to additional work for onsite (real time) packaging for disposal

- The next two weekends, E&O removed the piping and placed them into drums for disposal.
- OESO personnel were onsite to monitor the Hg vapors during removal.
  - High levels (>0.025) were not recorded during the piping removal.

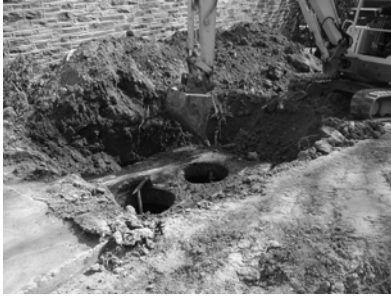
- The E&O Plumbing Shop Supervisor located the acid neutralization tank that would have been impacted by the previous project.
- Tank is believed to have been installed during original construction of Duke South (approx. 75 years old).
- When tank was opened, we discovered that the tank was full of sludge.
- E&O and OESO EP prepared a proposal to replace the old tank and remove the sludge.

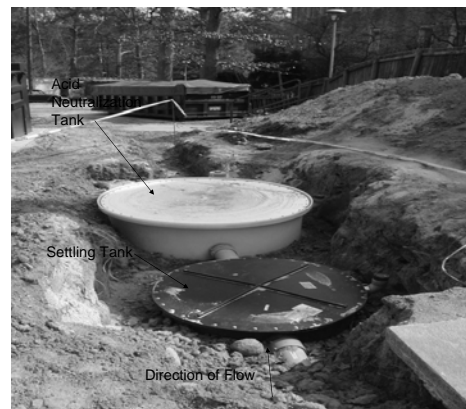
- New acid neutralization tank was reengineered based on the lab results.
- A small settling tank was added to the plan to “settle” the Hg out of the water before the AN tank.

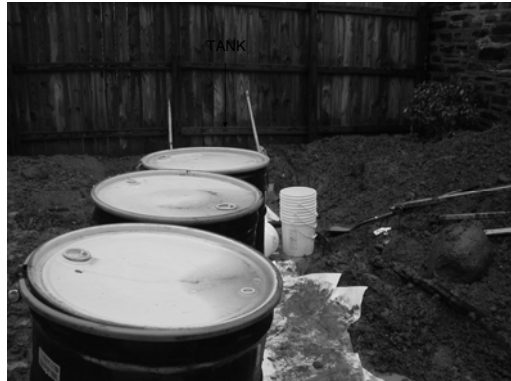
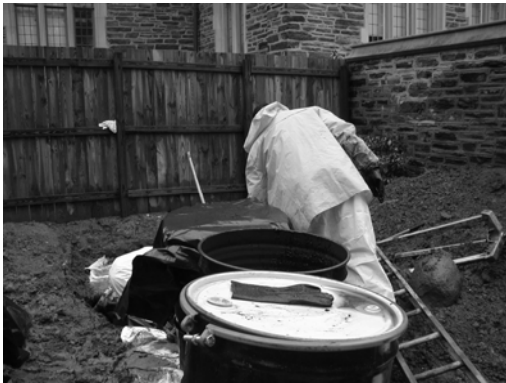
Sludge removed from tank.

- Total of 13 drums (715 gallons) of sludge were removed from the tank.
- Laboratory analysis of the concrete indicate tank is non-hazardous.
- Tank was filled with sand and closed in place.
- Still to do – Sample the effluent of the new tank system to determine effectiveness.

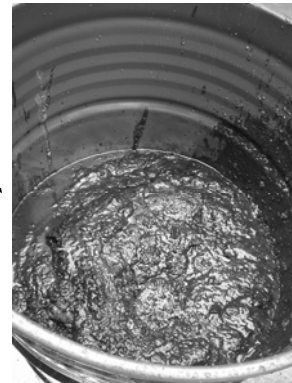
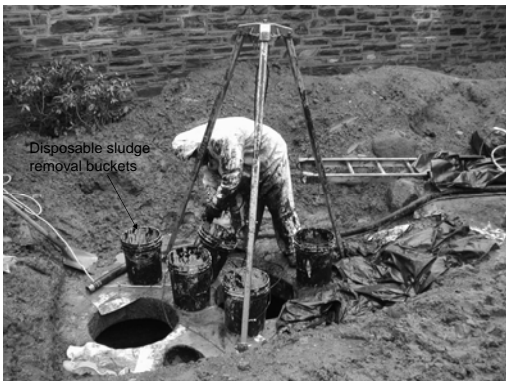
Disposable sludge removal buckets

Decon of Tank (removal of mud from shoes)
